## U.S. Environmental Protection Agency Vasquez Boulevard I/70 Superfund Site Replacement Certificate

VB/I-70 Command Post 10 E. 55th Avenue Denver, CO 80216 This spreadsheet performs screening level calculations to estimate the effect of peeling leaded paint on the average concentration of lead in yard soil 4644 High St.

This spreadsheet performs screening level calculations to estimate the effect of peeling leaded paint on the average concentration of lead in yard soil 4644 High St.

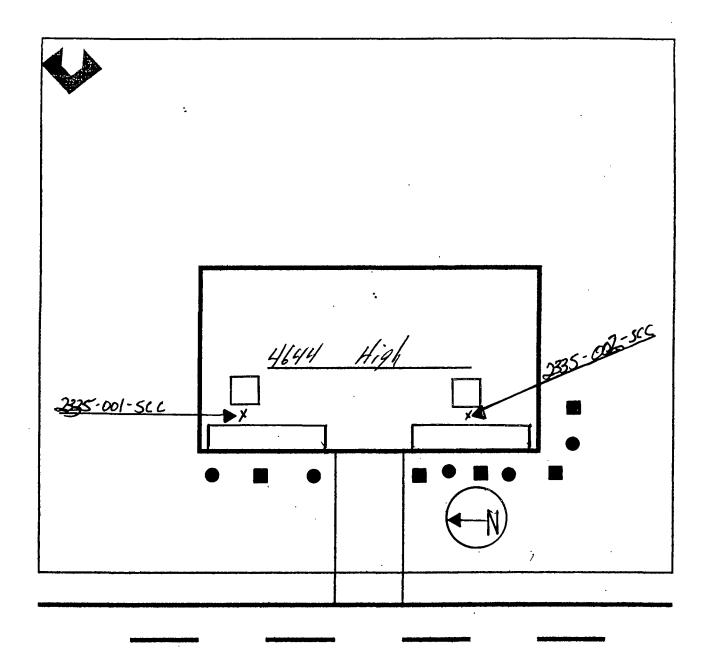
1) 2335-001-7000	14:25 Hours	04-26-06
22335 -002-DWC	14:35 HODES	04-26-06
312835-001-SCL	14:50 HOURS	04-26-06 FRONT Porch
412335-001-SCC	15:00 Hours	84-26-06 FRONT PORCh
5)		
6)
